Real-Life Injuries in Offset Frontal Collisions

A. Brent Eastman, MD, FACS
Steve Erwin
San Diego CIREN Team

March 16, 2001

Offset Frontal Case # 1

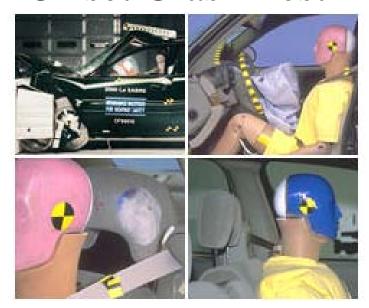
TOP LEFT: Action shot taken during the frontal offset crash test <u>Larger photo</u>

TOP RIGHT: The dummy's position in relation to the steering wheel and instrument panel after the crash test indicates that the driver's survival space was maintained well. Larger photo

BOTTOM LEFT: Smeared greasepaint indicates where the dummy's head contacted the head restraint and shoulder belt housing during rebound. Front lap/shoulder belts are mounted to the seats. Larger photo

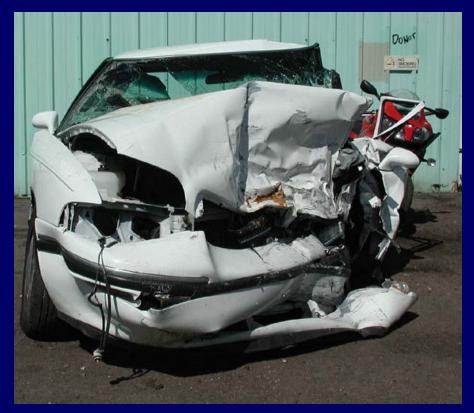
Subject Vehicle 1999 Buick LeSabre

Direct Damage = 60 cm (40% offset)

PDOF = Zero

Maximum Crush = 97 cm

WinSmash Delta V (ROLDMISS)

Total = 87.8 kph (55 mph)

Longitudinal = -87.8 kph

Barrier Equivalent = 69 kph (43 mph)

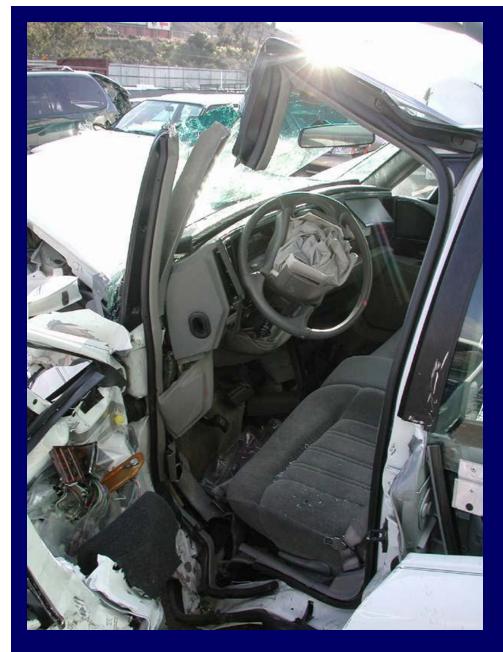
Intrusions Include: LF Toe Pan - 28 cm/ LF Dash - 26 cm

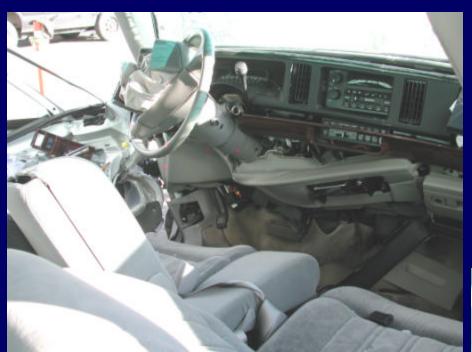
Contact Points Include:

Steering Wheel Rim (deformed)
Steering Column Base (transfer)

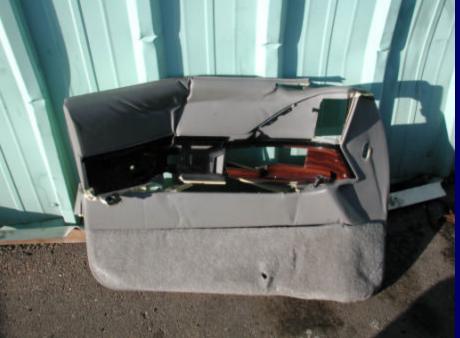
Suspected contact to driver door panel (contaminated during extrication)

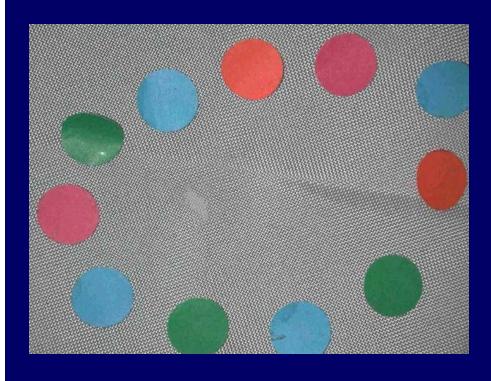
Occupant Contact Points (cont:)

Air bag (fluid transfer)

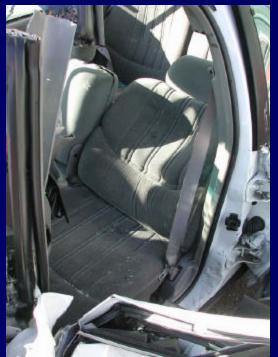
Driver seat, subject's location.

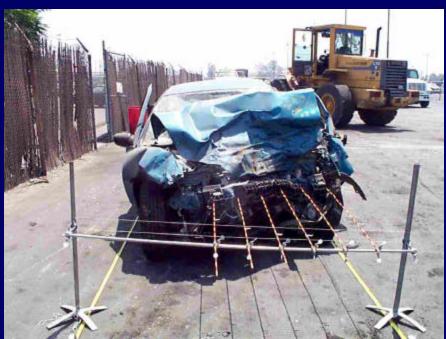
Subject Vehicle

Maximum Crush

104 cm

PDOF –10 degrees

Total Delta V (ROLDMISS) 68 kph (42 mph)*

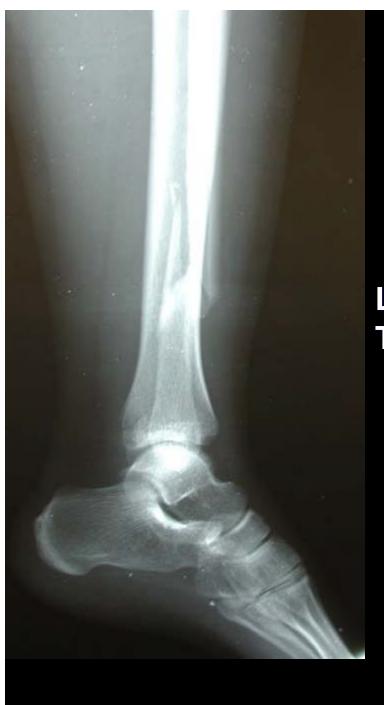
Left Tibia/Fibula

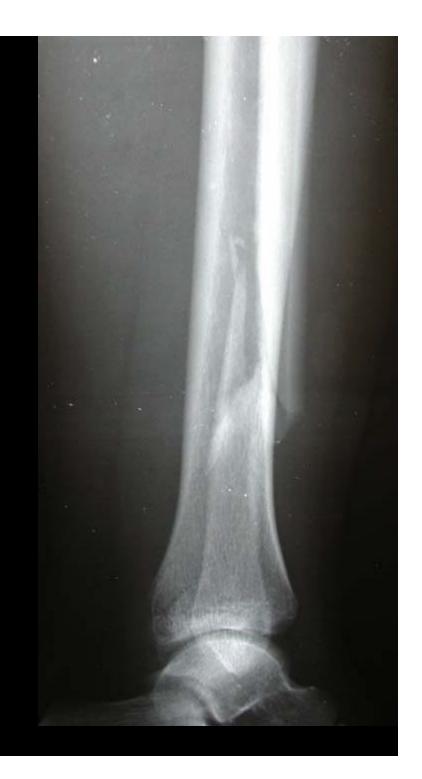
Right Tibia/Fibula

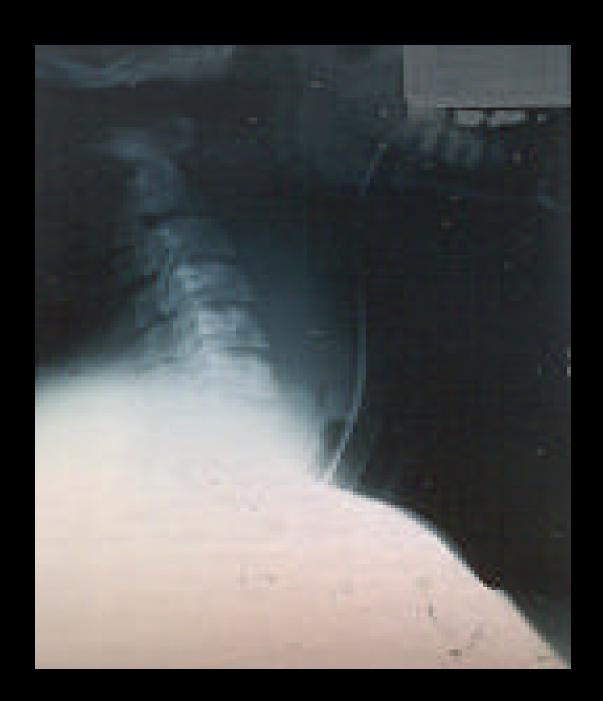
Atlanto-Occipital Dislocation

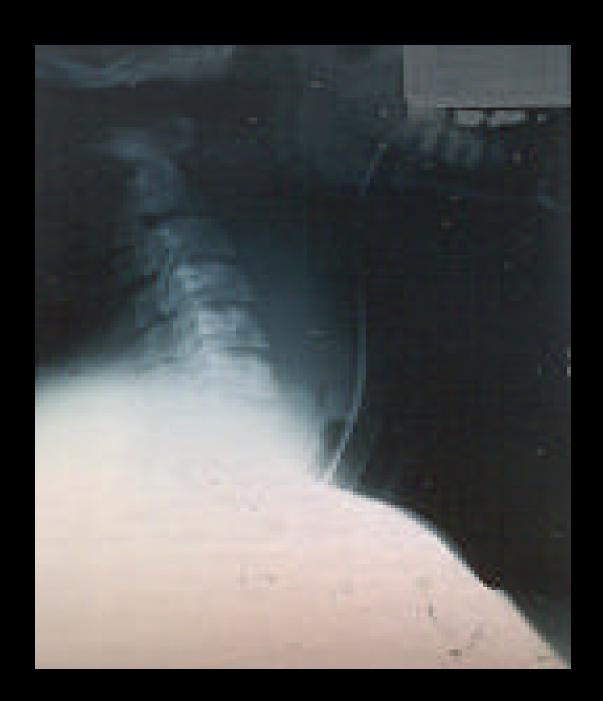
Atlanto-Occipital Dislocation
